EXISTING PLAN

| Itemref | Quantity | Title/Name, designation, material, dimension etc | Article No./Reference |
|---|---|--|---|
| EXISTING BUILDING | | | |
| 1ST Knowle Scout HQ | | | Edition |
| 1KSG / PA-07 / 01 | | | Third |

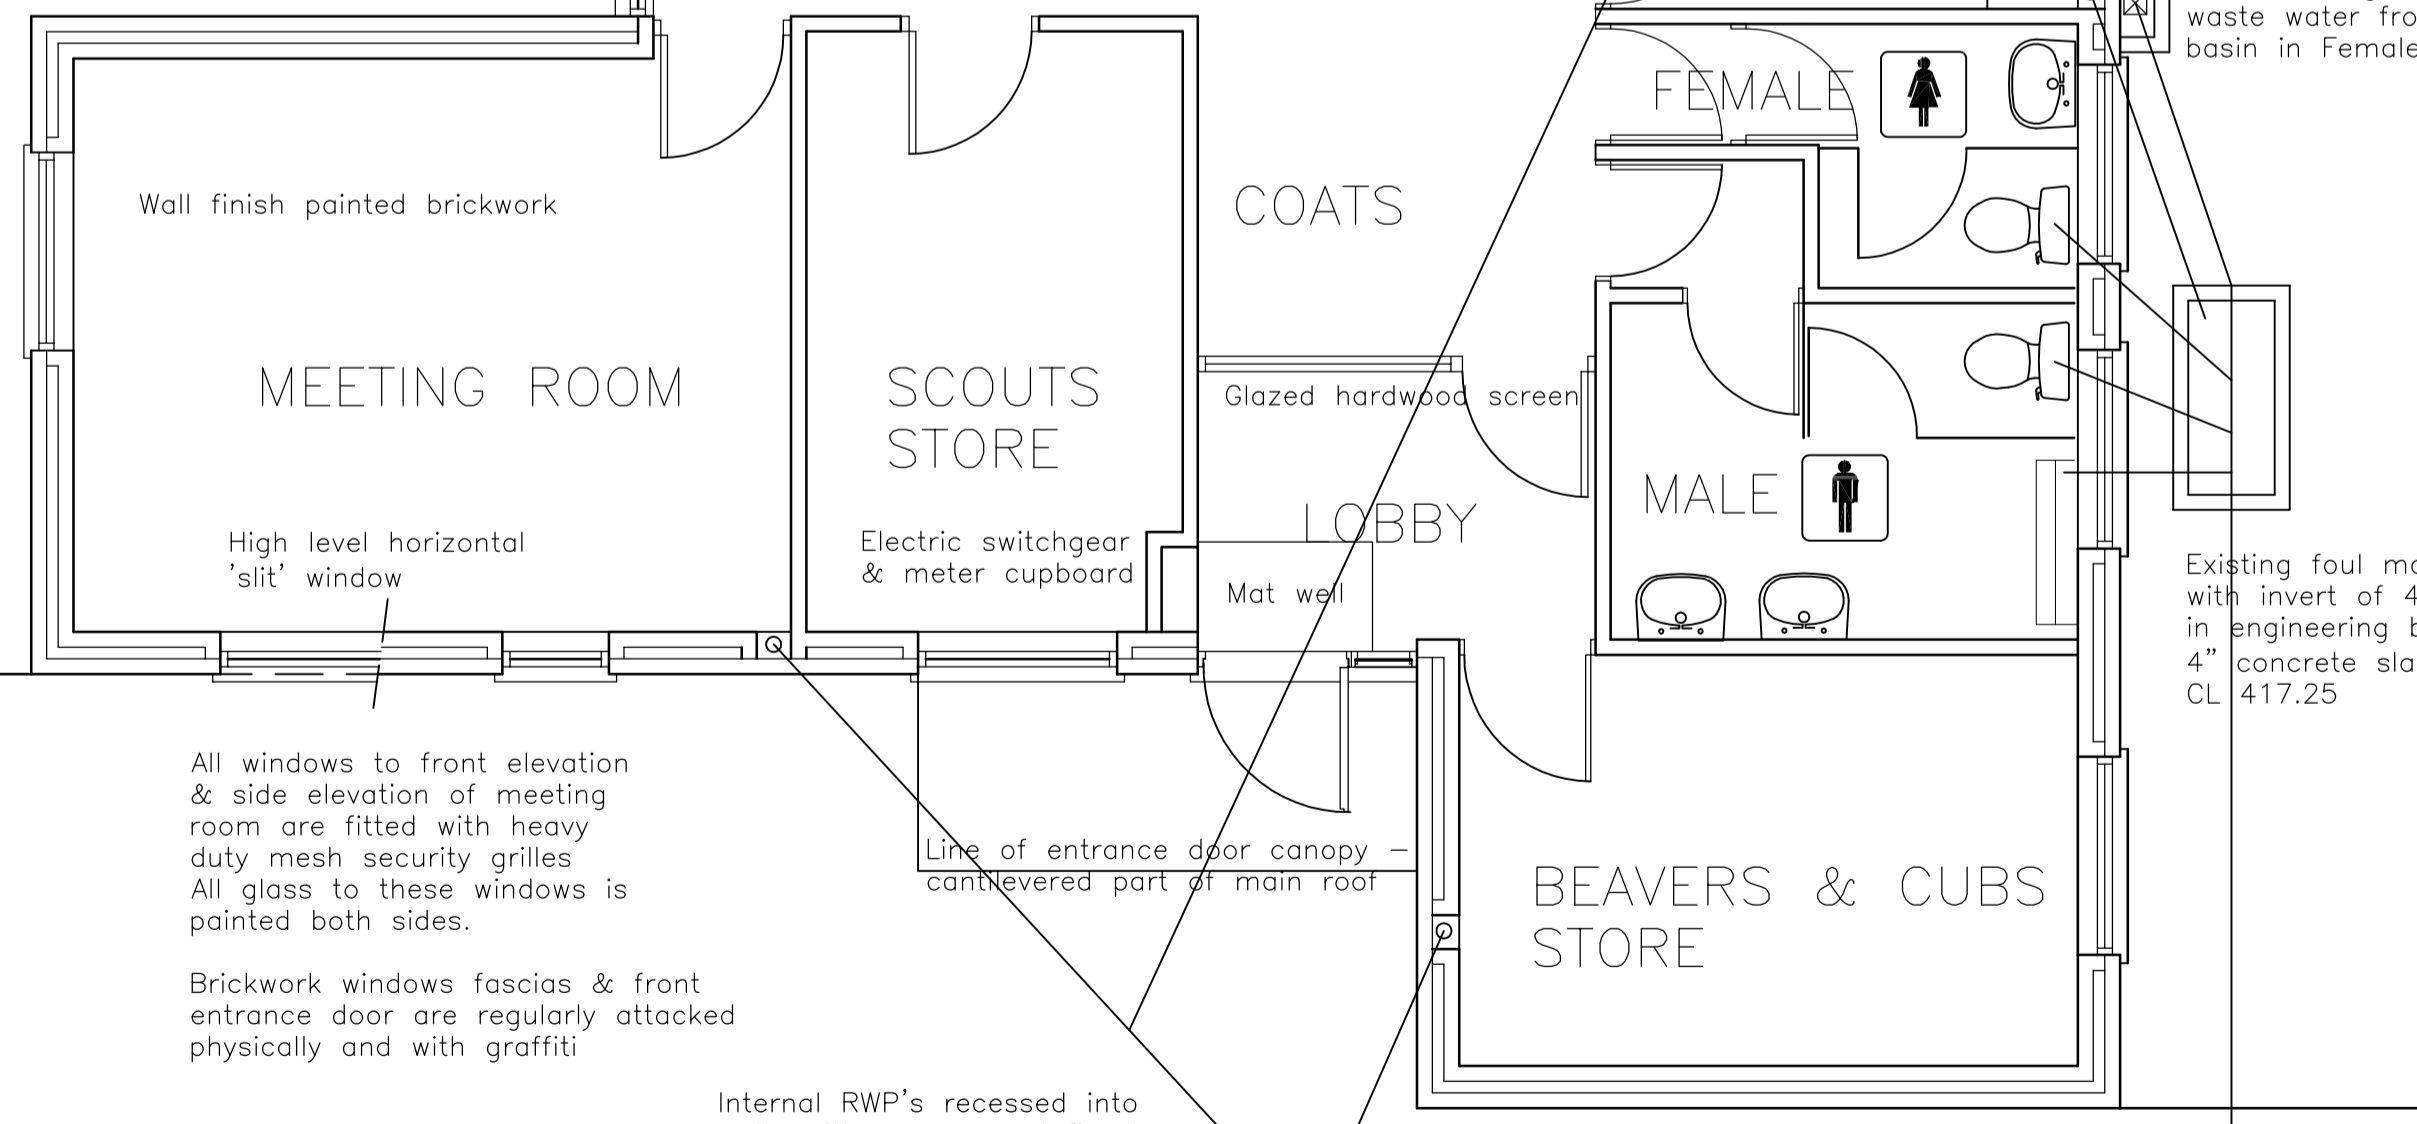
Fire exit door with no external landing ironmongery requires urgent attention door requires easing for better fit

All external walls appear to be 11" thick brickwork consisting of 2No skins of 4½" brickwork with a 2" cavity. Where these walls transition to internal walls the construction changes to 9" solid wall
 Wall finish painted brickwork
 Condensation on walls suggests poor ventilation & inadequate heating supplied by 4No. electric fan heaters at mid height & angled downwards

Galzing to the hall is provided by an array of different sized galvanised steel framed single glazed windows at mid height of the hall and in varying states of repair glass having been replaced by polycarbonate in some of the larger frames. The majority of the windows are fixed lights, most of the remaining that were designed to open no longer do.

Hardwood strip flooring appears to be in a reasonable condition however, a proper inspection of the floor void below possibly by camera might be a good idea. A past repair in the centre of the floor requires attention. (- possible trip hazzard).

Pair of doors in poor repair (nailed shut) Evidence of water ingress above door also roof leaks along adjacent external wall.

Pair of doors in poor repair lipping to leading edge of fixed leaf loose door handles require replacement.

Roof appears to be in generally sound condition consisting of 2 layer asbestos based bitumenous roofing felt with chippings finish over 3" channel reinforced interlocking wood wool slabs. These span between the walls and 3No. 10x5¼"x25lb U.B's fixed on padstones at 5'

Internal RWP cover removed

Kitchen sink drainage leak in the past possible water beneath vinyl floor finish poor levels of hygiene acheivable. Long term damp damage to plaster finishes due to roof leaks.

Single glazed window in poor state of repair Hot water supply by "on-demand" wall mounted electric boiler - efficiency and age unknown. Long term problems with inner RWP adjacent to serving hatch this single pipe takes all of the drainage off the Main Hall roof with a branch to an outlet taking stormwater off the flat roof as well.

Female WC constantly wet floor & walls due to partial collapse of ceiling, again long term damage to the roof structure decking & supporting structure requires instant remedial work for short term continued use of the facility. Plasterwork damaged and sanitaryware in deteriorating condition

Male toilet facility comprising: urinal trough with auto flush cistern over draining to open glazed clay floor trough to drain (broken/missing strainer) Wc with old type flushing cistern. Chrome - pitted & corroding

2No wash basins with crazed glazing these drain to the open floor trough. Walls plastered throughout with tiled splashback to wash basins. Plaster to outer wall suffering from long term damp from leak in roof above. Partial collapse or removal of ceiling plasterboard due to long term roof leak & constant wetting of deck & timbers.

No external survey of the Main Hall roof has been carried out. Internally the roof appears to be in generally sound condition and consists of: 2 layer asbestos based bitumenous roofing felt with chippings finish on 3" thick channel reinforced interlocking wood wool slabs. These span between the walls and 3No. 10x5¼"x25lb U.B's fixed on padstones built into the walls below providing a 5' roof pitch

Falling lead flashings

Lower area of failing flat roof with numerous patch repairs lifting felt joints and failing flashings

Assumed failing lead flashings to gutter behind low parapet
